Instructions for Updating Devices with ISP

Protocol for Developers Wanting to Update Devices with ISP

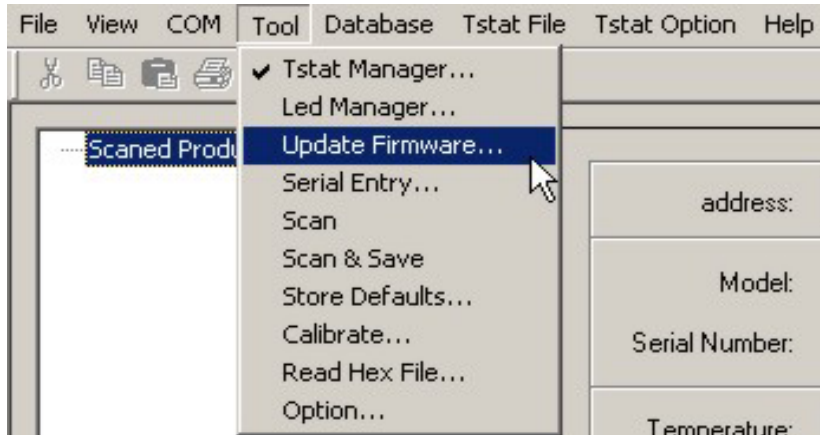
1. Download and install the MPC manger software: <http://www.automatikprodukter.se/ftp/software/MPCSoftware.zip>.
2. Connect the device to the serial port of your computer using RS232-485 converter included in the package.
3. Power up the device
4. Open the MPC Manager software and select Update Firmware from the Tool menu:

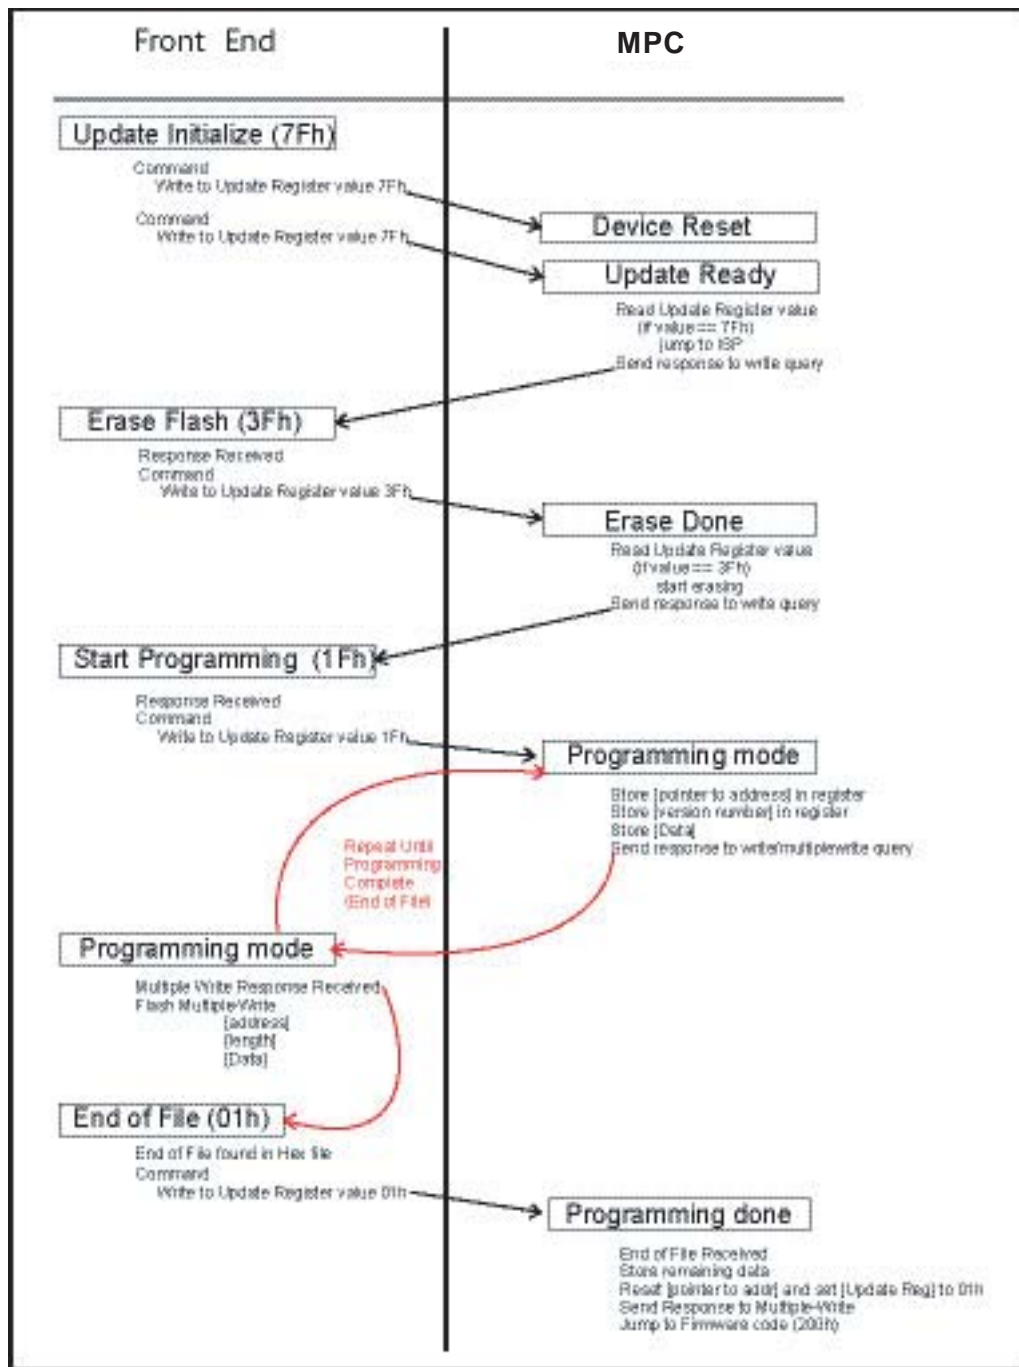
Below is a diagram representation of the Flash-Update Protocol.

Example of a Programming Routine (Front End Side)

- 1 - Send the Modbus Write command to address Update_Register value 7Fh
The device will reset itself.
Make sure all volatile information be saved prior to this step
Device will not send a respond
- 2 - Send Modbus Write Command to address Update_Register value 7Fh again.
A response will be received if the Device has properly reset itself and booted under ISP mode.

- 3 - Send the Modbus Write Command to adress Update_Register value 3Fh
A response will be received once the Device has properly set itself for programming mode
This will step require a longer response timeout period (approx 500ms).

- 4 - Send the Modbus Write Command to adress Update_Register value 1Fh
A response will be received once the Device has properly Erase all Flash memory
This will step require a longer response timeout period (approx 500ms).

- 9 - End of file found in Hex file:
:00 0000 01 FF
Bit 7 and 8 are 01
- 10 - Send Modbus Write Command to address update_Register value 01h
This will cause the device to reset itself and boot in normal operation mode.
